# **PERFORMANCE TESTING OF THE MUSCLE WALL**

Muscle Wall, LLC

**Report No. 2167**

# PERFORMANCE TESTING OF THE MUSCLE WALL

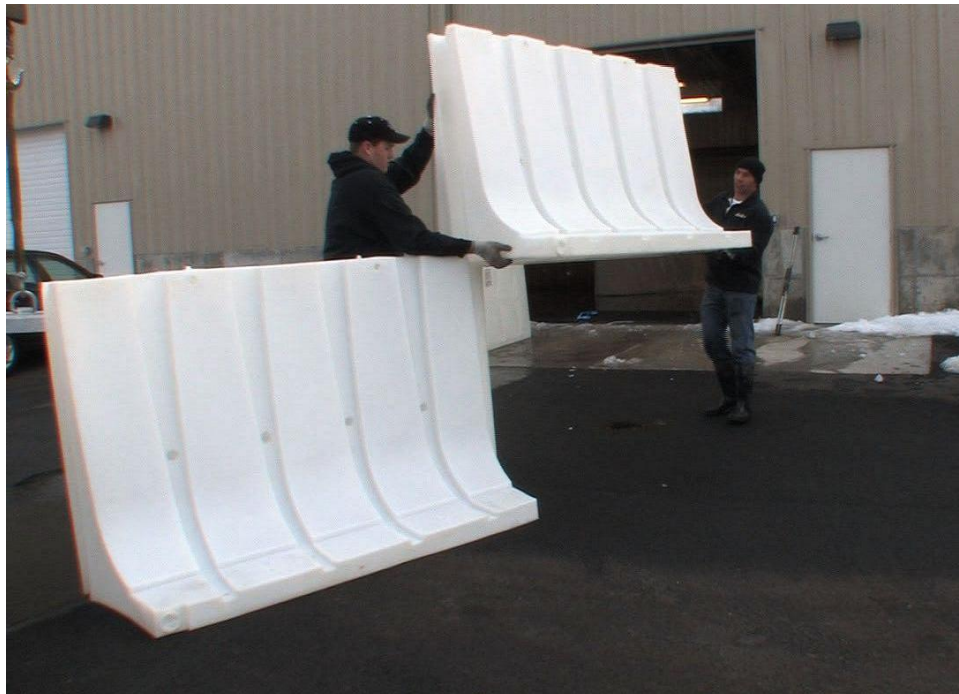
The Muscle Wall system consists of lightweight hollow barricades that are designed to be interconnecting. The connection is effectively a hinge that allows adjoining barricades to pivot which enables the wall to make sweeping bends. In addition, corner pieces are used to allow 90-degree bends. Figures 1 and 2 show the Muscle Wall and the hinged connection.

Figure 1. Muscle wall sections.

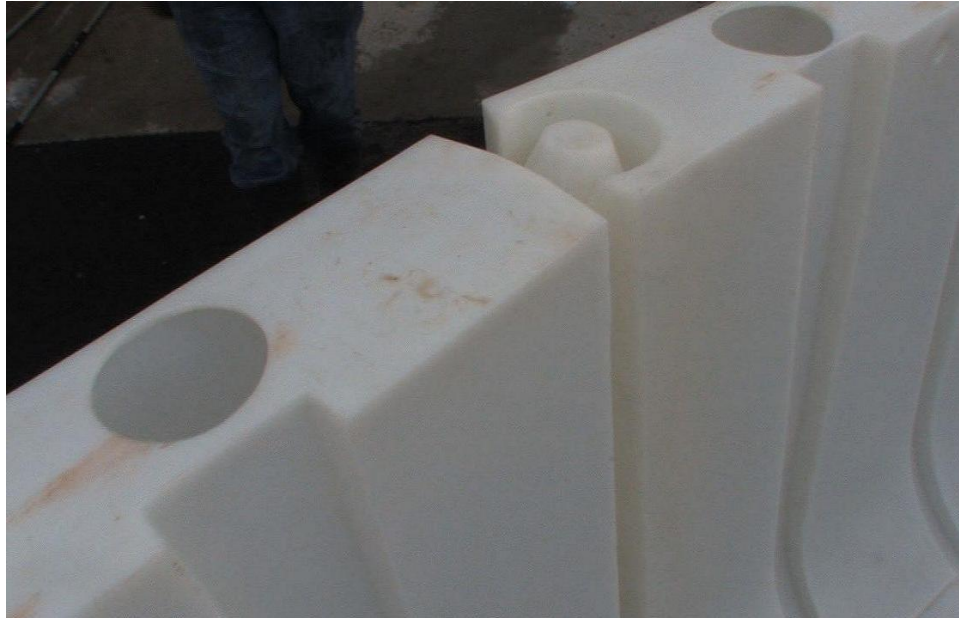
Figure 2. Muscle wall hinged connection.

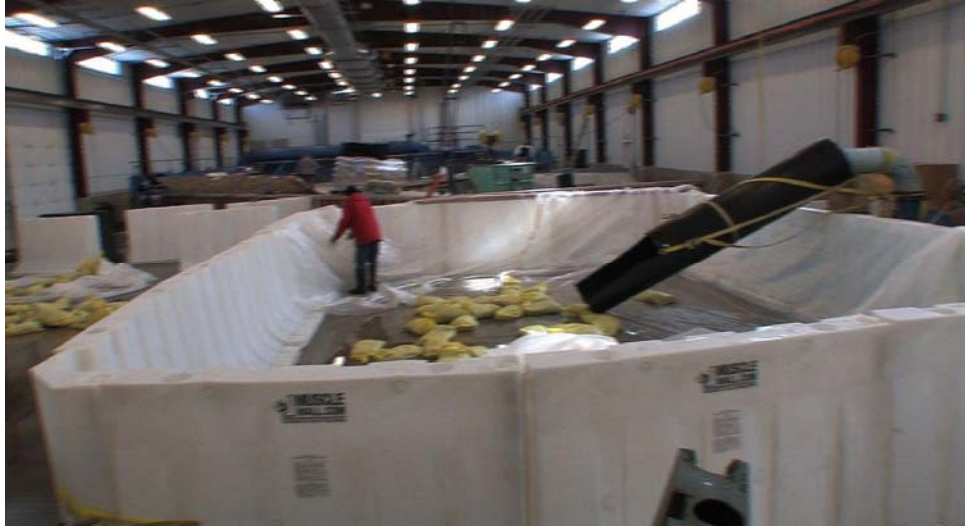
The first installation of the Muscle Wall was done at the Utah Water Research Laboratory's Hydraulics Modeling Building (Figure 3.). The barricades were installed on an extremely smooth concrete floor and the standard reinforced plastic was placed on the inside of barricaded area. Sandbags were used to keep the reinforced plastic in place while filling. This installation represents the most adverse of installations that may be possible. The Muscle Wall hinged connections were the only mechanism of restraint to prevent wall movement. The Muscle Wall is designed so that stakes can be used to restrain the wall from sliding when used on soil or asphalt.

Figure 3. Muscle wall installation at UWRL.

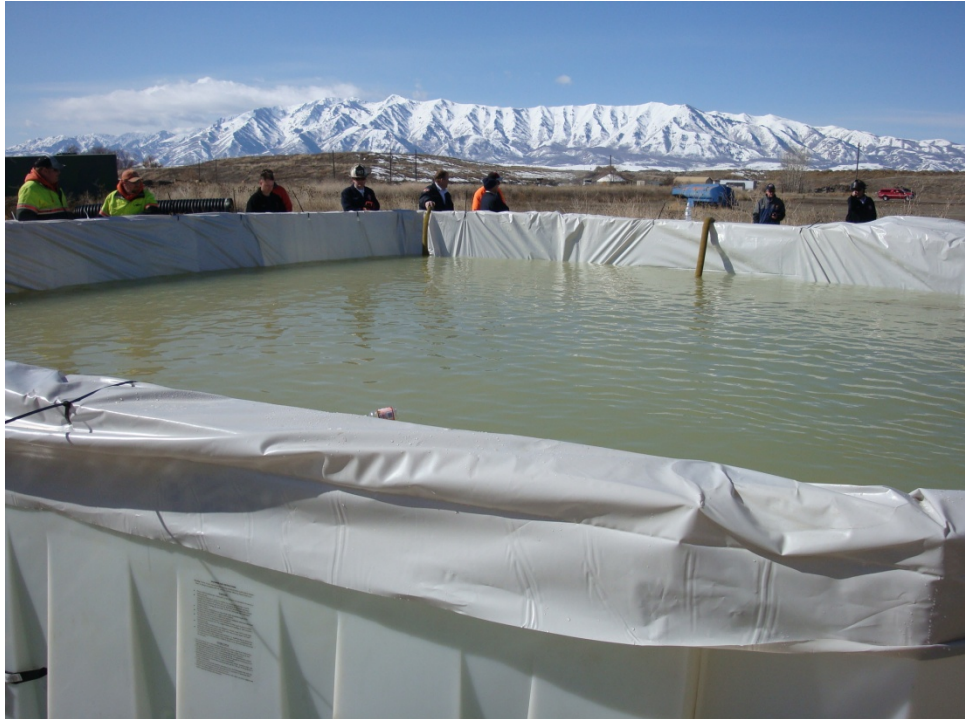
The second installation of the Muscle Wall was done at the Logan City Fireman Training facility. Again this testing was completed on concrete; however nylon straps were used to tie each barricade together to prevent barricade separation at the joint. Plastic with a thickness of ten mils was used on the inside of the barricades. Figure 4 shows the installation for this series of tests. Figure 5 shows the straps used to tie adjacent walls together and keep them from sliding on concrete.

Figure 4. Muscle wall at Logan City's firefighter training facility.

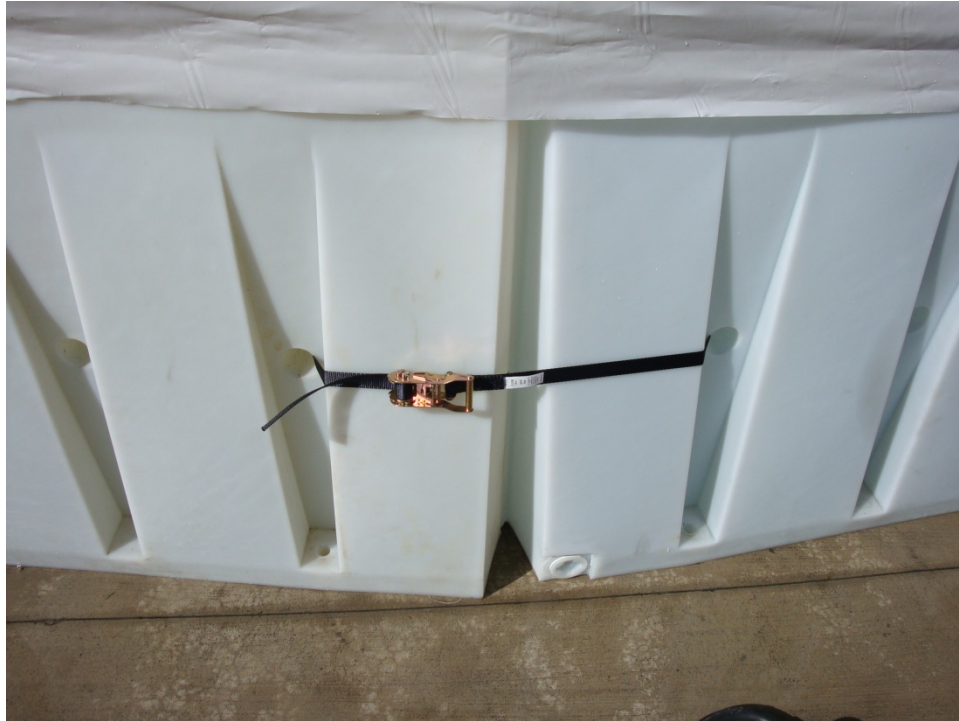
Figure 5. Strap used to secure walls together.

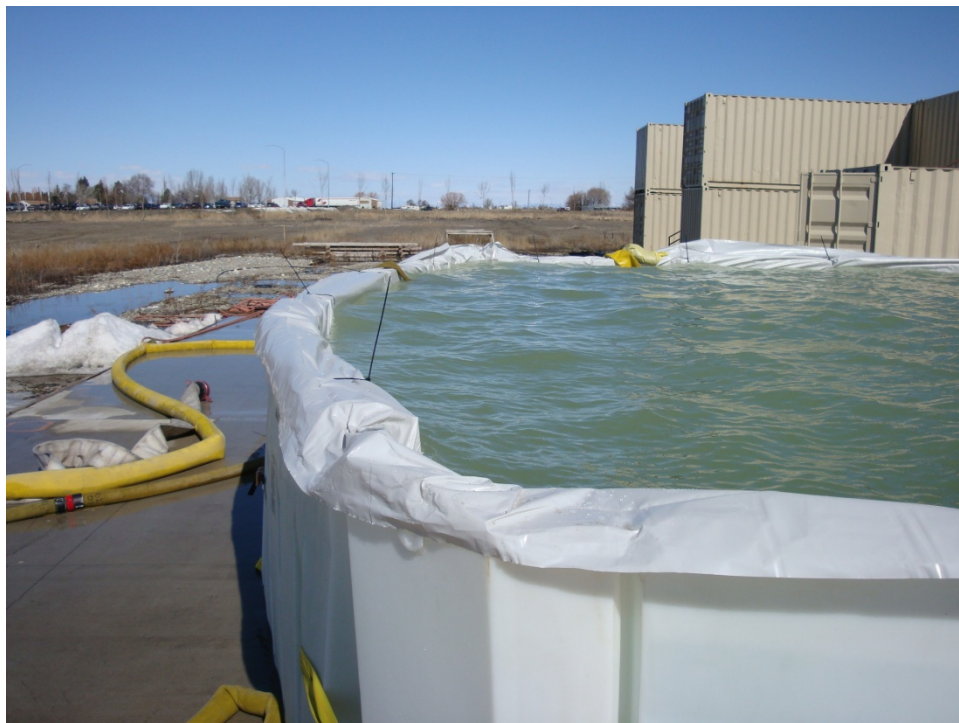
Waves were generated in both facilities by raising and lowering a steel plate with a crane or forklift. The Muscle Wall barricade showed no problems with waves at the Logan facility when connected together with straps. At the UWRL, the testing was done at a depth of about 36 inches and showed no problems. Figure 6 shows the Muscle Wall with considerable wave interaction.

Figure 6. Muscle Wall wave test.

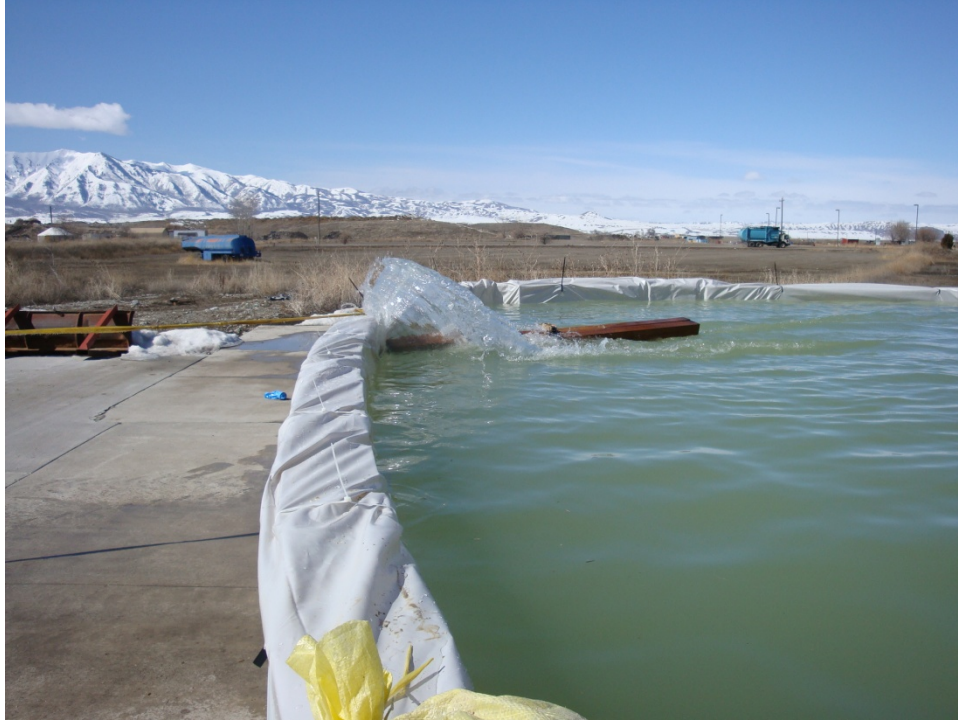
A 6-inch x 6-inch x 144-inch timber was used to impact the Muscle Wall. The timber was accelerated to approximately 5 feet per second and slammed into the wall. The result was simply a small puncture in the plastic liner. The timber rebounded and the wall was not displaced. Figure 7 shows the timber impacting the wall.

Figure 7. Impact test.

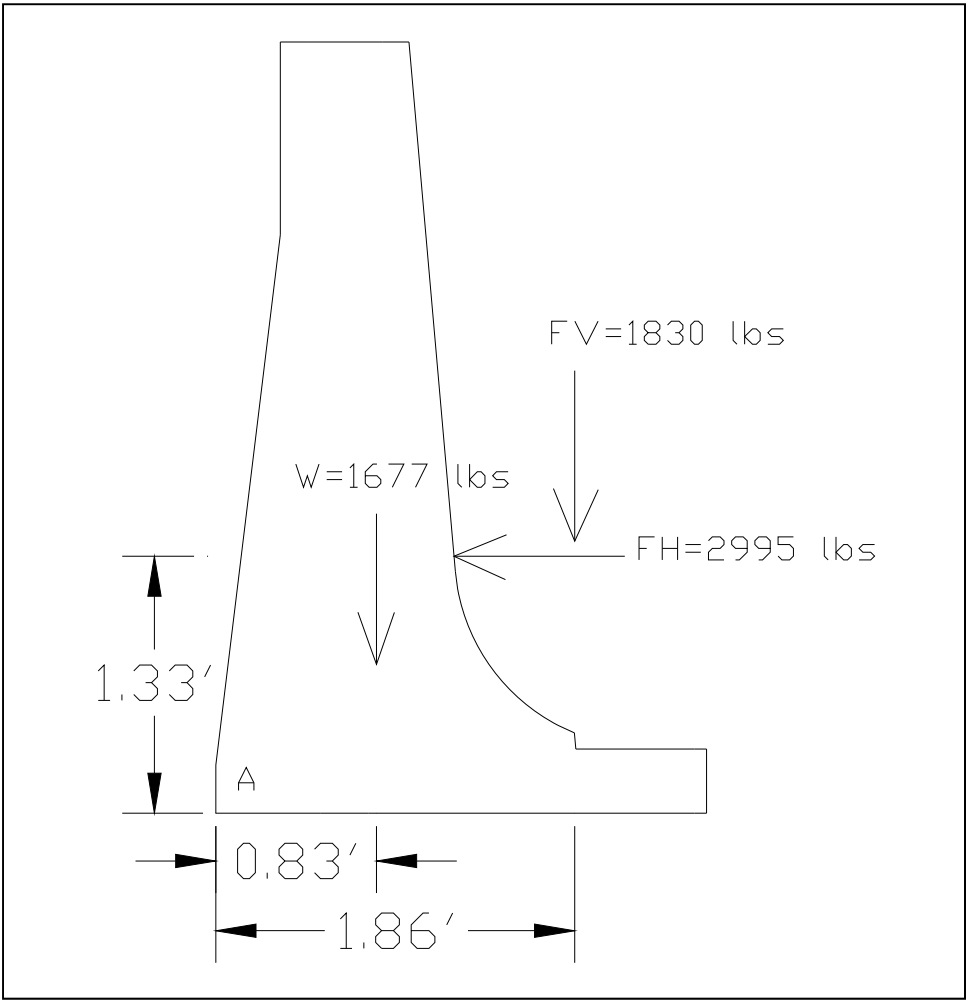
The analysis was completed to show if the Muscle Wall would overturn without end restraints. Figure 8 shows the free-body diagram with the representative weight forces, and pressure forces that act horizontally (FH) and vertically (FV) on the Muscle Wall. The forces shown are located at the centroids of the Muscle Wall and running through the centroid of water over the toe and at the location where the horizontal hydrostatic force would be located.

Figure 8. Free-body diagram of the Muscle Wall and resultant forces.

Taking the overturning moment about point A with overturning moments assigned positive values and resisting overturning moments assigned negative values yields:

$$M_A = 2995 * 1.33 - 1677 * 0.83 - 1830 * 1.86 = -812.4 \text{ ft} \cdot \text{lbs}$$

Because the resulting overturning moment is negative the resisting overturning moment is greater than the overturning moment. Therefore, a properly installed Muscle Wall should not overturn if four feet of water is being restrained.
